✓ LLOYDELL DAM

( ID NO. PA. 500 )

✓ PHASE I INSPECTION REPORT  
NATIONAL DAM INSPECTION PROGRAM

PHASE I REPORT  
NATIONAL DAM INSPECTION PROGRAM

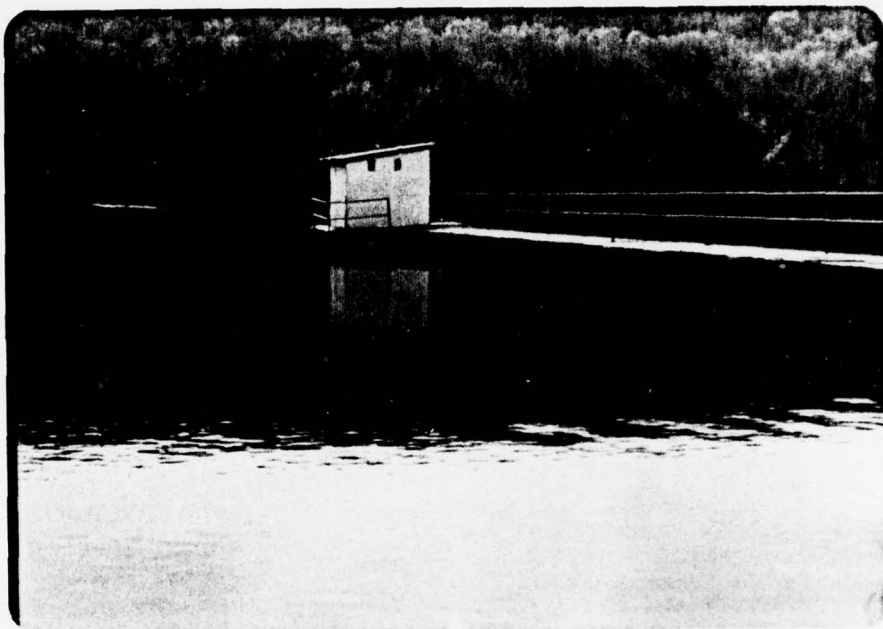
Upstream Face

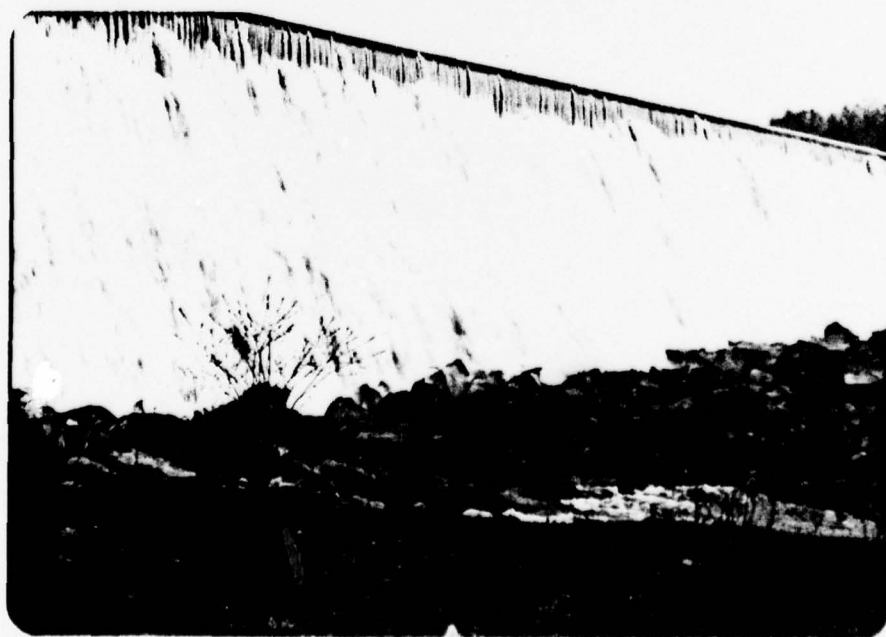
Downstream Face

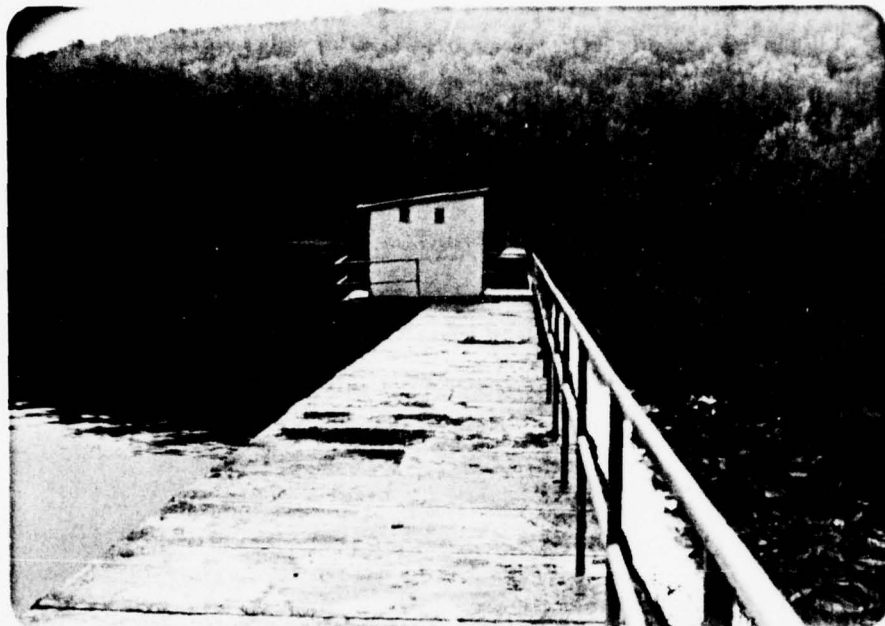
Photograph No. 1  
Dam crest.

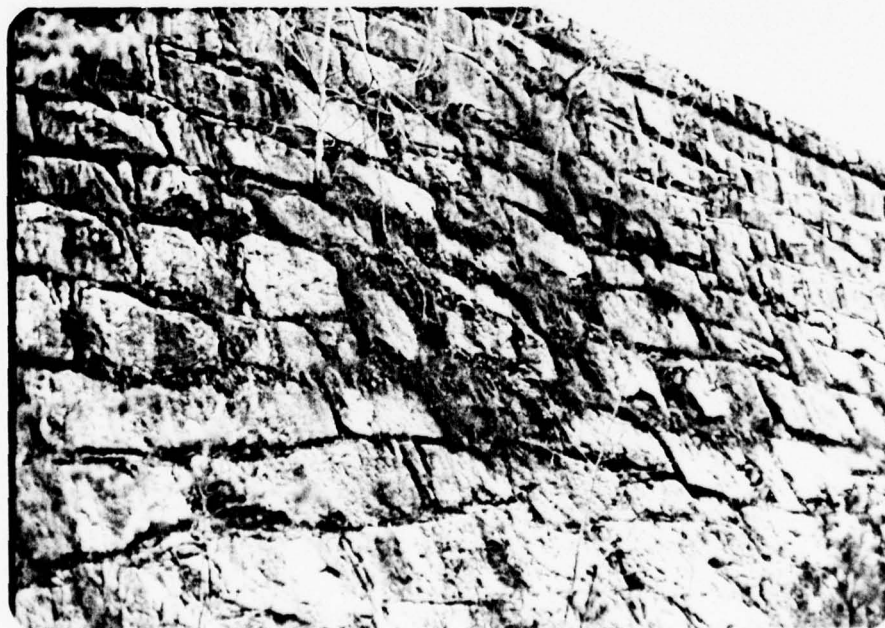
1. The entire downstream face of the dam was found to be wet. Approximately five concentrated seeps were observed through the dam over a distance of approximately 125 feet on the left of the spillway. The discharge from the seeps was estimated to be in the range of 2 to 5 gallons per minute (gpm).
2. Over a distance of approximately 100 feet on the left side of the spillway, the joint mortar on the facing stones was found to be spalled and grass and small trees were growing on the joints.
3. Four coping stones adjacent to the left side of the spillway were cracked and appeared to be loose.

Photograph No. 2  
Downstream slope.

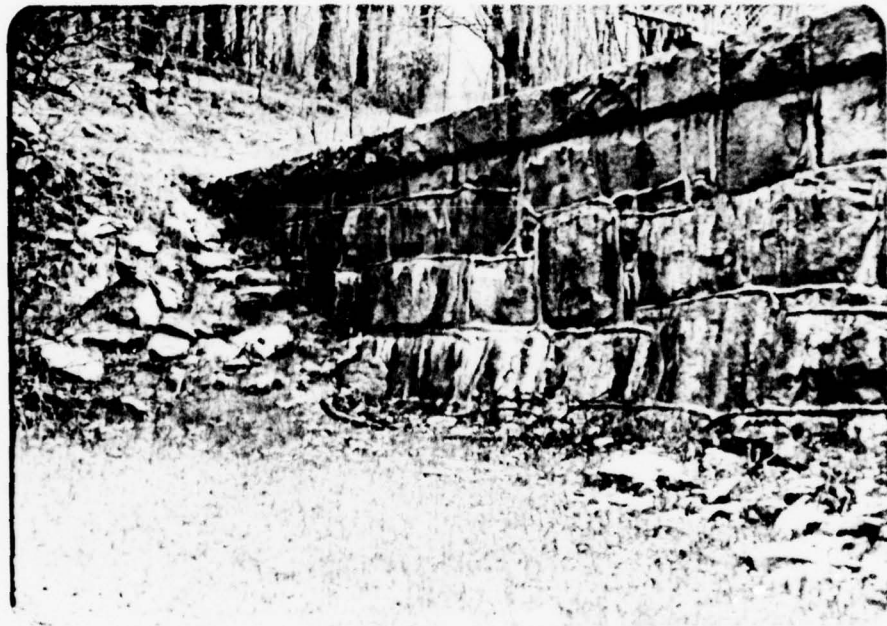
Photograph No. 3  
Right abutment.

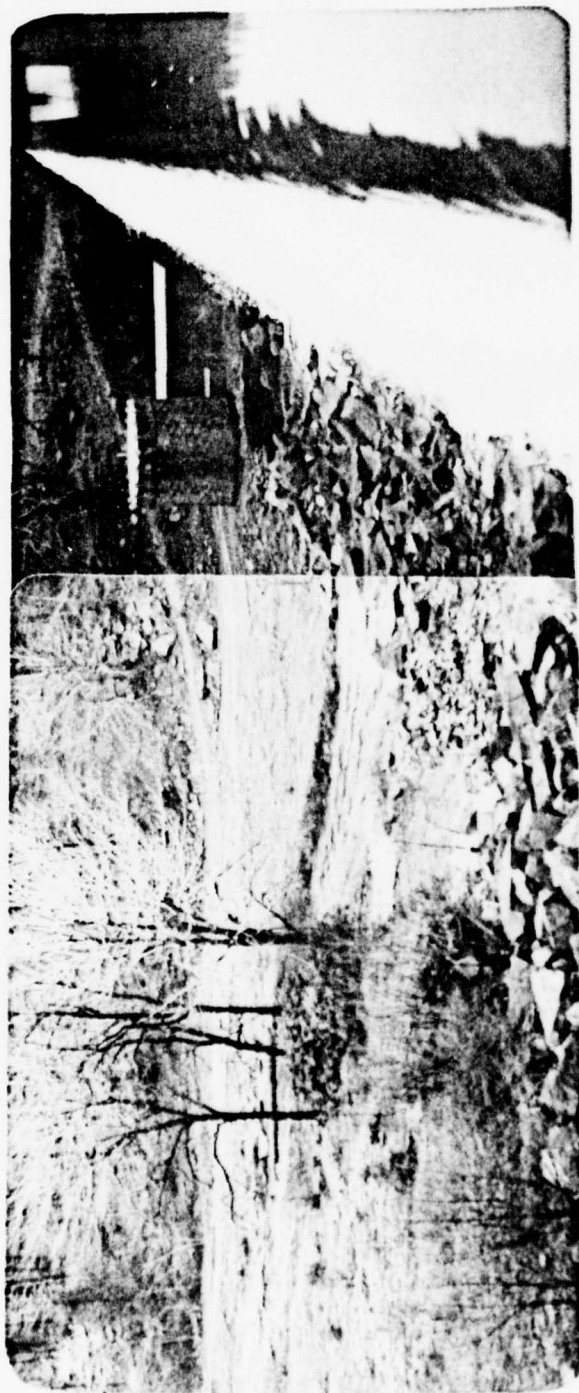
c. Appurtenant Structures. The spillway crests and plunge pools were examined for deterioration or other signs of distress and obstructions that would limit flow. No signs of apparent distress or erosion were observed.

Photograph No. 4  
Spillway, plunge pool, and spillway discharge channel.

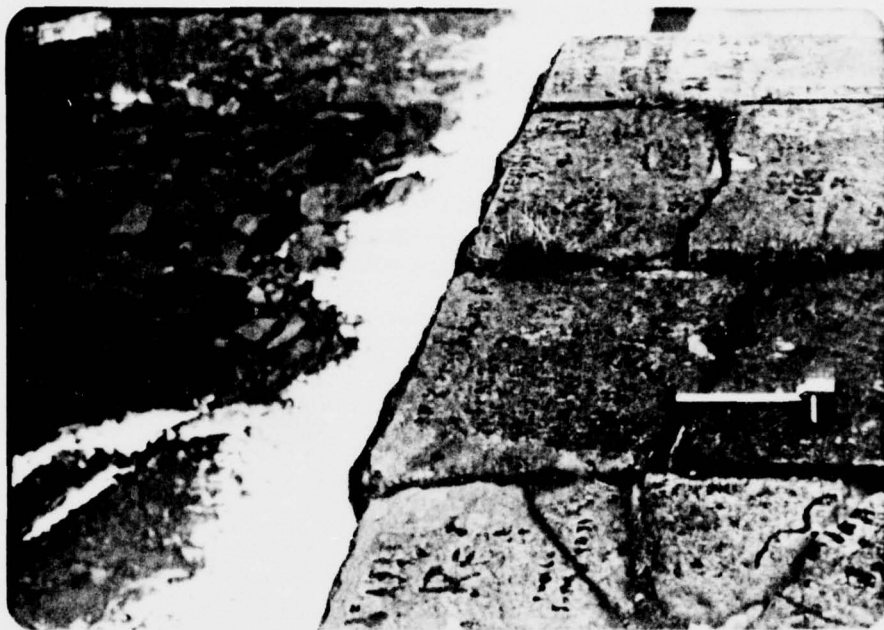
VISUAL EXAMINATION OF	OBSERVATIONS	REMARKS OR RECOMMENDATIONS
SURFACE CRACKS CONCRETE SURFACES	A - CRACKS ON THE CREST CAPPING STONE (LEFT OF SPILLWAY)	SEE PLATE 4 FOR LOCATION.
STRUCTURAL CRACKING	NONE FOUND	
VERTICAL AND HORIZONTAL ALIGNMENT	NO PERCEIVABLE MISALIGNMENT.	
MONOLITH JOINTS	MASONRY DAM ∴ N/A.	
CONSTRUCTION JOINTS STAFF GAGE OF RECORDER:	(NO CONSTRUCTION JOINTS) NONE FOUND.

Photograph No. 5  
Cracks in capping stone (left of spillway).

3.2 Evaluation. In general, the condition of the dam is considered to be good. However, repairs to the stone facing joints would be required to avoid further damage due to frost action. Clearing of brush from the face and toe area of the dam is also required to permit adequate continued inspection of the toe area.

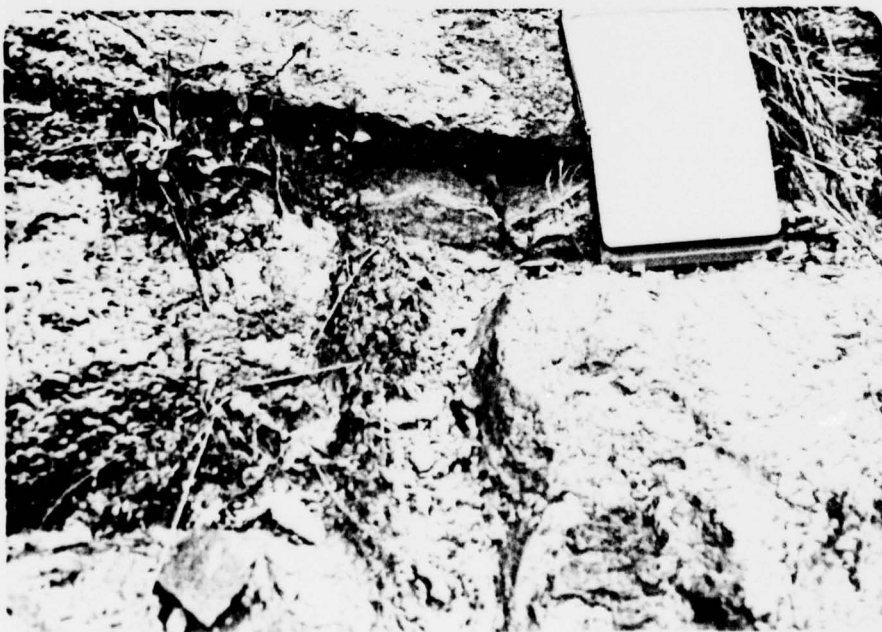
Photograph No. 6  
Seepage through joints on downstream slope.

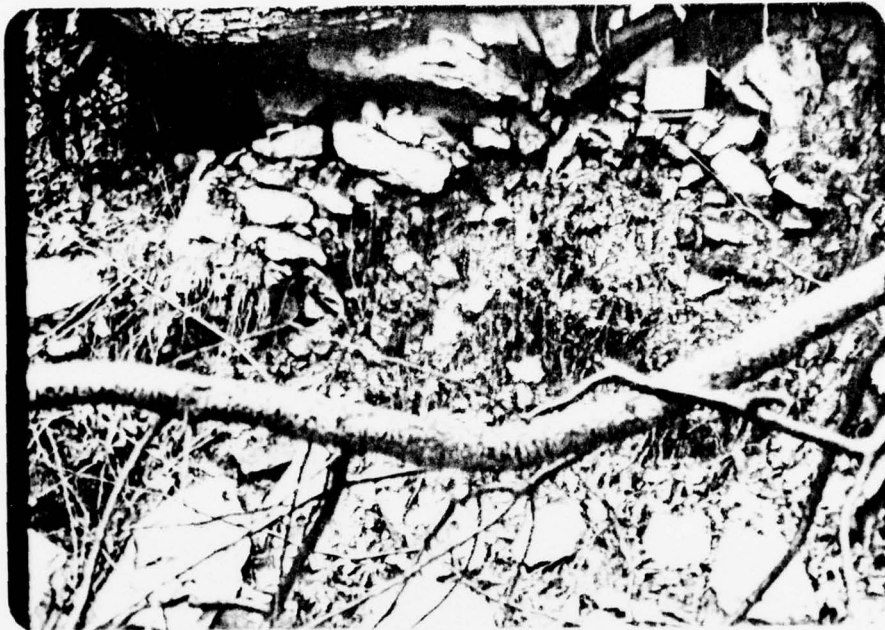
4. A major spring discharging approximately 50 gpm was found on the left abutment approximately 300 feet downstream from the dam at an elevation approximately 3 feet below the dam crest.
5. One concentrated seepage point was found on the right abutment. It was located approximately at the toe level and 100 feet downstream from the dam. The flow was estimated to be 5 to 10 gpm.
6. Numerous grout holes were observed on the crest of the dam. The appearance of the grout material suggests that the grouting was done at various times in the past.

Photograph No. 7  
Seepage at right abutment.

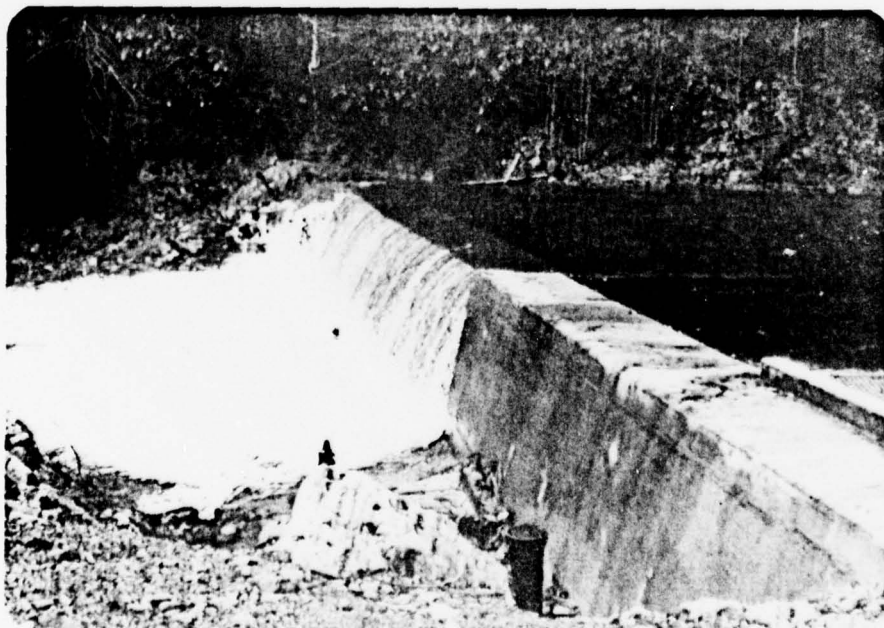
Photograph No. 8  
Distribution pond located 2 miles downstream.

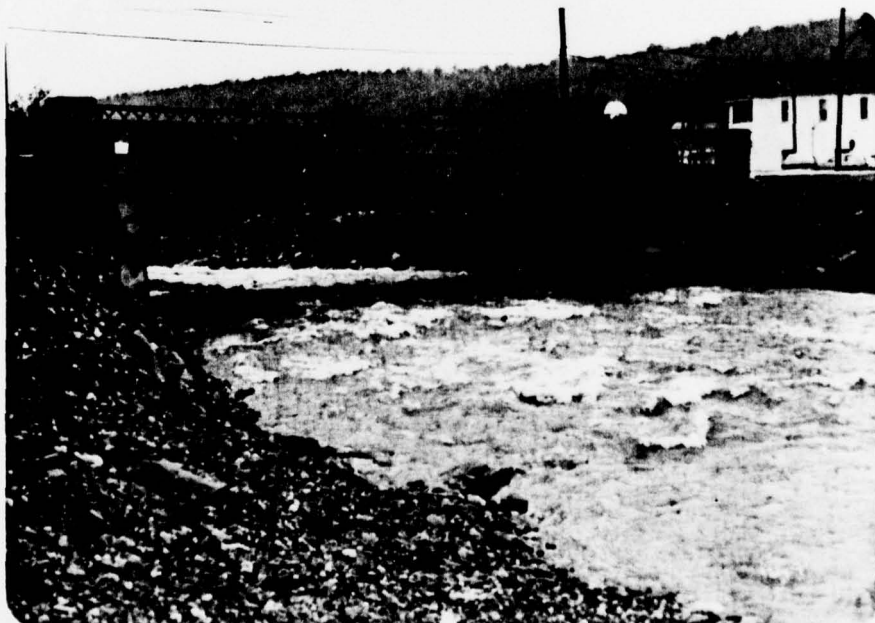
Photograph No. 10  
Bridge No. 2.
